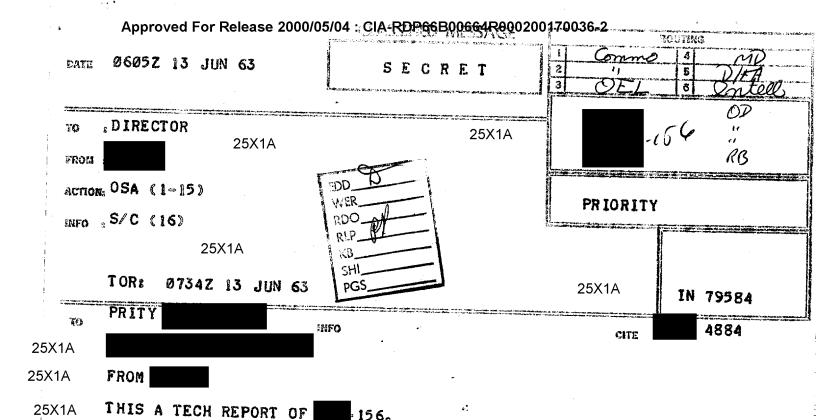
THE S AND X BAND RECORDINGS WERE EXTREMELY NOISY FOR THE FIRST PART OF MISSION. THE LEVEL OF THE 1 KC ON BOTH RECORDERS SHOULD BE RAISED. THE 3 KC SWITCHING TONE ON MASTER RECORDER WAS EXTREMELY WEAK. EXCEPT FOR USUAL COMMENTS ON COMMAND RECEIVER RECORDINGS, OTHER EQUIPMENT OPERATED SATISFACTORILY.
